# OPEN SAFETY EQUIPMENT LTD FAMILY OF REBREATHERS

## FAILURE MODE, EFFECT AND CRITICALITY ANALYSIS VOLUME 4:

### Mechanical Failure Mode Analysis

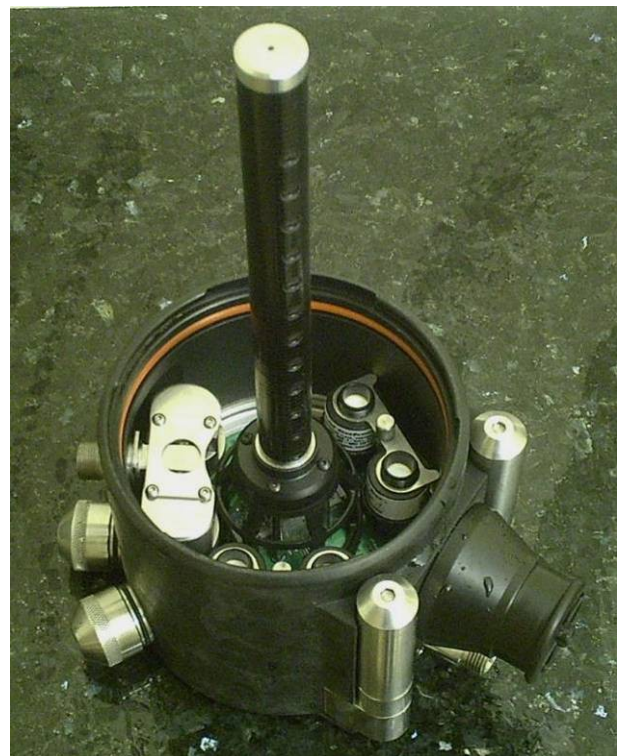
**Fig 3-4:** Multi-role professional eCCR head, physical realisation.

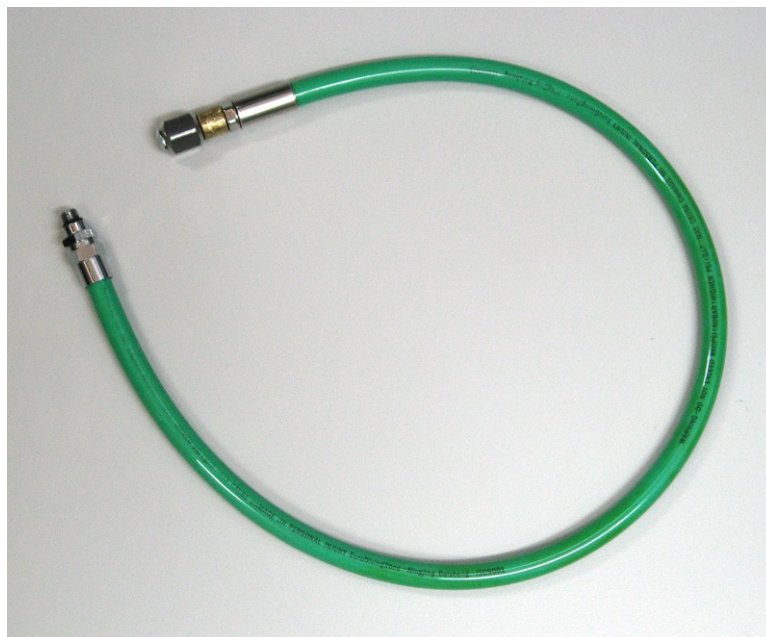
Fig 3-4-1: TPU Hose with crimp (top) and reusable (bottom left) fittings. The PEX hose looks the same, but is matt black.

The TPU hose is used for supply to the ALVBOV because it is highly flexible, and PEX hose is used for oxygen supply. Both hoses are marked in the same manner. Neither hose has a braided cover, for ease of inspection and decontamination.

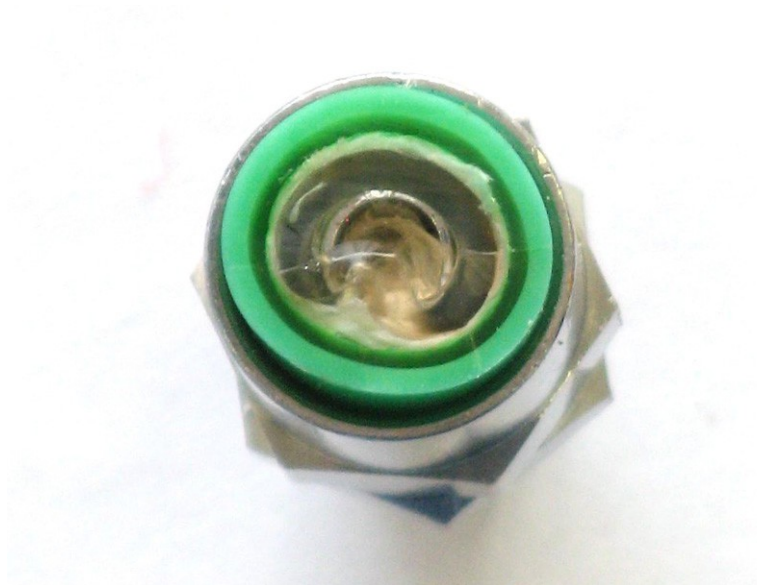
Fig 3-4-1: Section through hose that fails with a test pressure of 90 bar, showing how the reusable inner fitting has cut through the inner hose allowing gas to leak into the sheath.

- a) The end of the fitting is sharp instead of rounded AND
- b) No oxygen compatible grease is used when the fitting is assembled, then the fitting can cut into the inner wall, reducing the burst pressure from  $> 120$  bar, to 90 bar. In theory, the burst pressure could reduce to near zero. Gas travels up the Kevlar sheath and causes a hose failure that may be away from the end fitting.

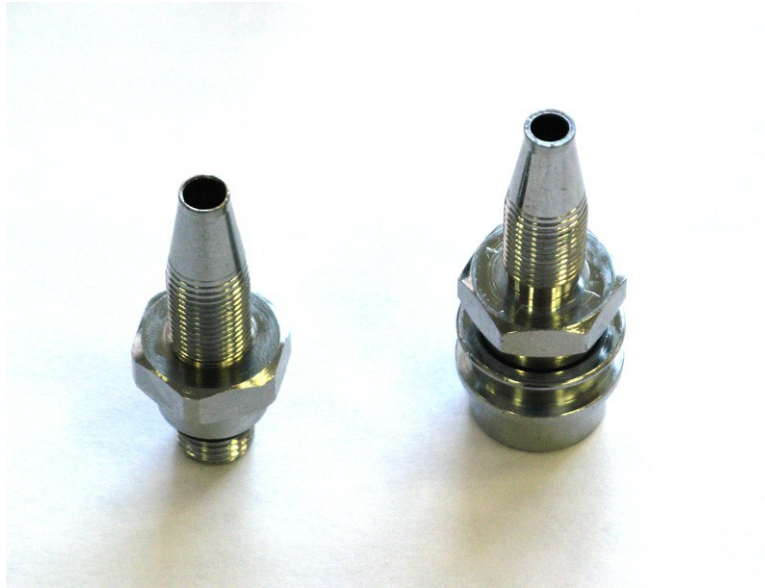
Fig 3-4-1: “Crimp and reusable fittings compared, inner core. It is essential that the end of the fitting is rounded to prevent the fitting cutting into the inner hose. All incoming material shall be inspected to ensure the fitting end is rounded, free of burrs and oxygen compatible grease shall be used on the end of the fitting when it is inserted into the hose to avoid it cutting the hose. Both the above fittings should fail the inspection for no sharp edges.

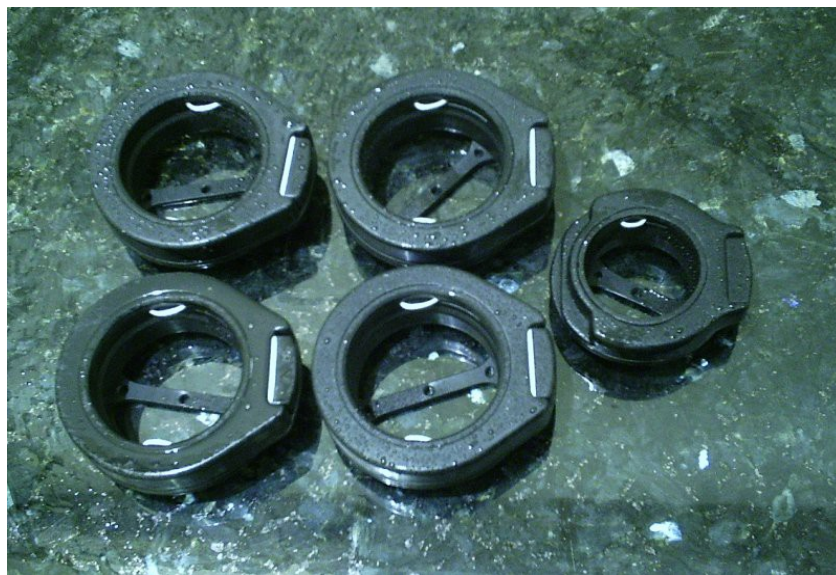
Fig 4-5: Four of the first generation Press-Click connectors used for the project with a Draeger P Port for comparison. In the review of the project, it was concluded that this solution does not meet the safety requirement: two distinct actions are required. The SCR is pressurised during ascent, so the pull action happens automatically due to the pressure

difference. This meant only one action remains to prevent the port releasing. Checks on other P Port users found two reports of a P Port releasing accidentally. The design was changed in light of this information, to that shown below. The mating part of the connector can be seen in Fig 3-9.

7. There were several reports on the internet and from other companies using Press-Click connectors that these had disengaged accidentally. One company, Narkedat90, had resorted to drilling a hole through the button and added a locking wire to prevent the button being pressed. From this feedback, it was concluded that what is apparently two actions to disengage the connector, (Press a button, then pull), is in fact one action because the pull can occur during differences in pressure between the loop and ambient. This problem was identified late on in the design cycle: all the other improvements had been implemented, built and tested before this issue was properly identified.  
The port prior to the change is shown in Fig 4-1, alongside the Draeger P port for reference, and the change to address this Accidental Disconnect risk is shown in Fig 4-2: a second button was added such that both have to be depressed.

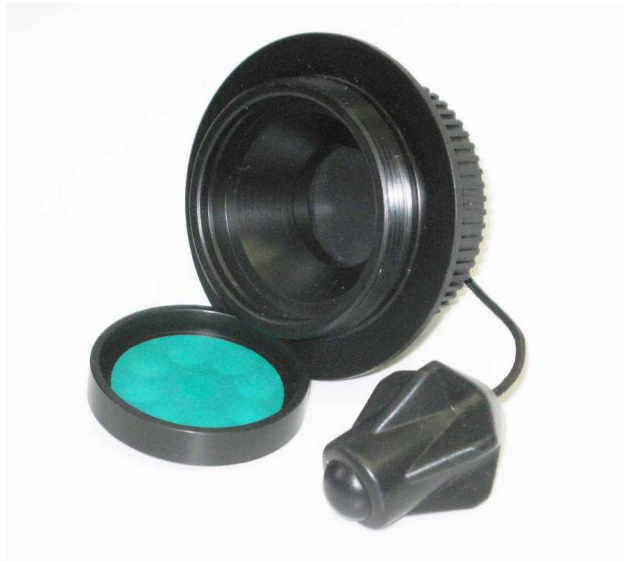
**Fig 4-7:** Original water dumps using one way valve and dump valve. Short toggle shaped to avoid snagging the dump. The cord is a Bowden cable, in May 2010, improved further by shortenng the cable to remove all slack in June 2010.

One customer reported that it is possible for the stopper to partially seal: this is a known failure mode of all BCD dump valves. The fault rectifies itself if the valve is pulled again and released. Twelve different types of BCD dump was tested and all could exhibit the fault. However, in the review process it was concluded that a better design was feasible, using a captive piston to prevent sideways movement. This eliminates this fault mode. Such a design was then carried out and tooled. Images of the result are shown below: original and improved.

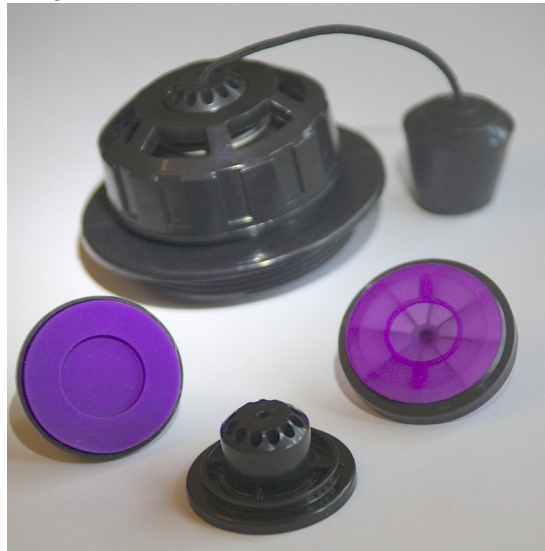
**Fig 4-8:** Improved water dump where the stopped uses a piston to prevent sideways movement. The valve is fitted with an umbrella one-way valve (purple component on right), and a contoured seal (purple component on left). The piston itself is shown in the foreground: the spring is welded and potted into the well around the piston, preventing it coming out under even extreme conditions of use. The cracking pressure of the pressure relief, and the flow cross sections, are unchanged from the original. The thread on the cap of the new valve is very large to avoid the risk of a user cross-threading it.

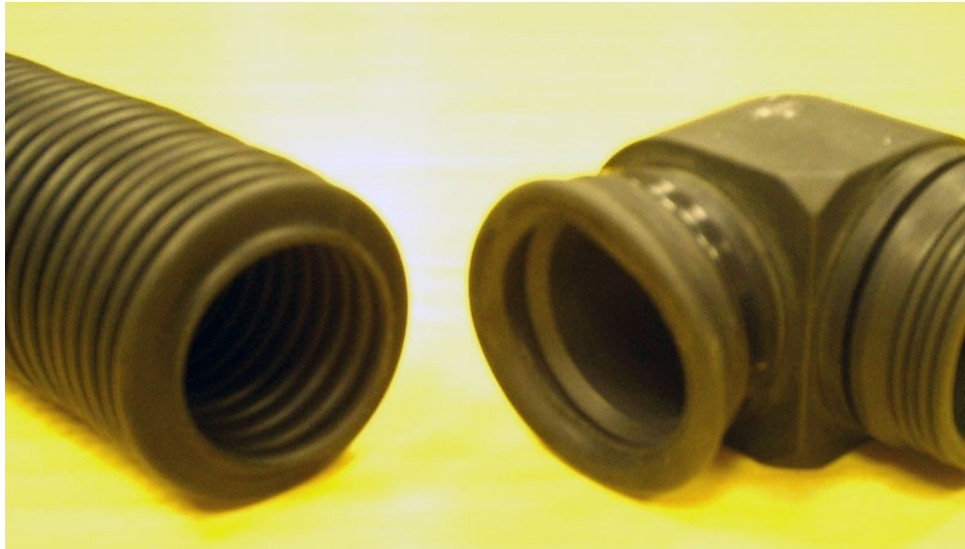
**Fig 4-9:** Hose failure on a 50kg load on a sample of the thermal re-formed hose. Note hose is still attached to port: the test was carried from port to mouthpiece. The cable clamps have not yielded and the creep is less than 1mm. Tests were carried out with both plastic clamps and stainless steel Jubilee clip clamps (that are used to attach the hose in production), in case a diver replaces the Jubilee clip with a cable tie in the field. Microscopic examination of the failure shows it to start at the point where the forming tool has grabbed the hose during its manufacturing process: there is a 0.3mm deep cut on every ring of the hose where this failure can start. The hose material was subsequently improved and the thickness increased: the new hose withstands a 100kg pull.

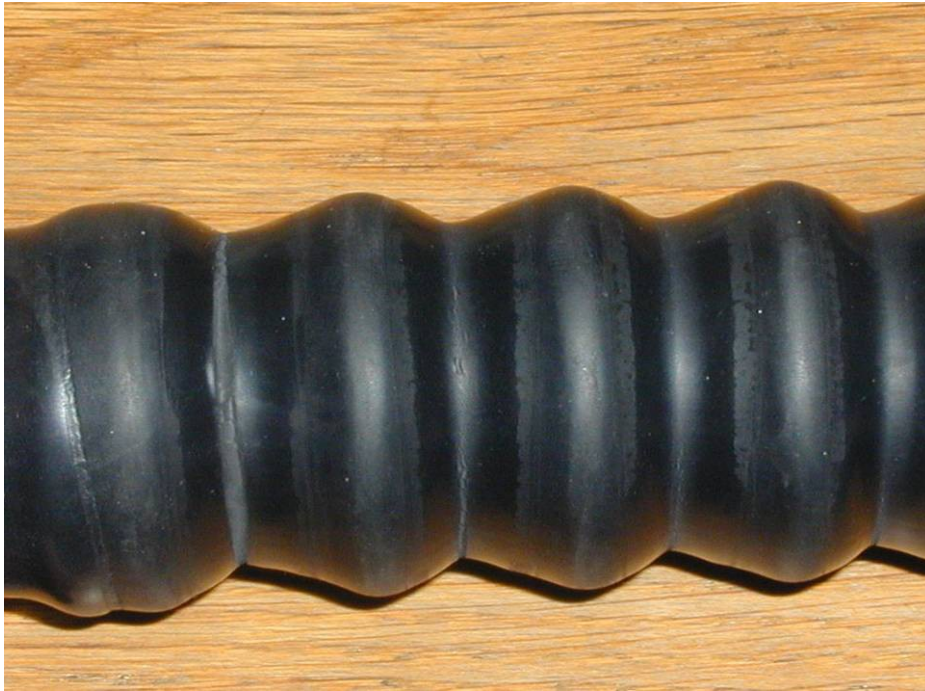
**Fig 4-10:** Hose under tension showing cracks caused by forming tool during manufacture, from which failures extend around the hose. Manufacturer agreed to address this by much more frequent cleaning of the forming tool than for non-critical applications. New hoses withstand a 100kg pull test.

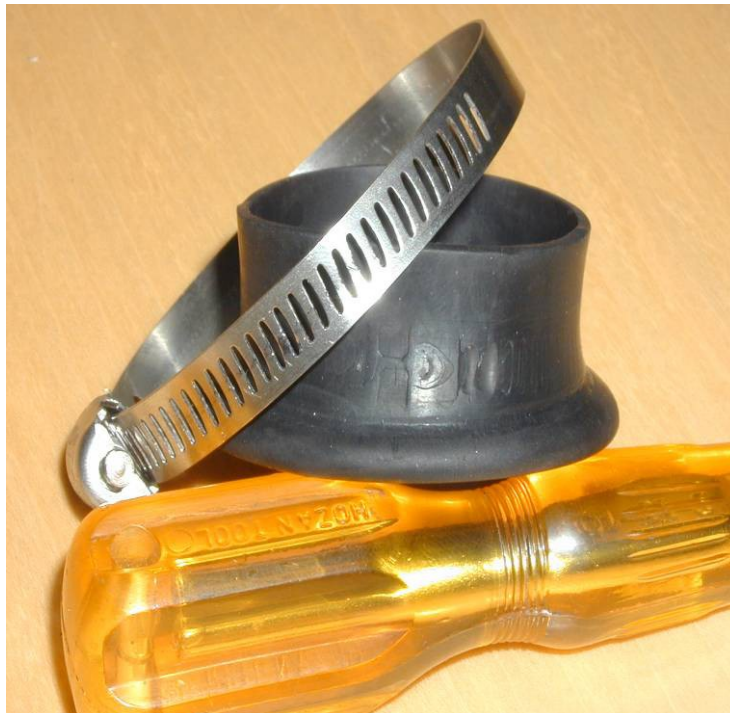
**Fig 4-11:** Hose with jubilee clip, after tensioning the clip until the grub screw failed, then tensioning the hose until the hose failed. Hose failure point is at the same point observed in the tests reported in the previous section. The hose is attached using a Jubilee clip identical to the one shown, at both ends, in all configurations of the rebreathers.

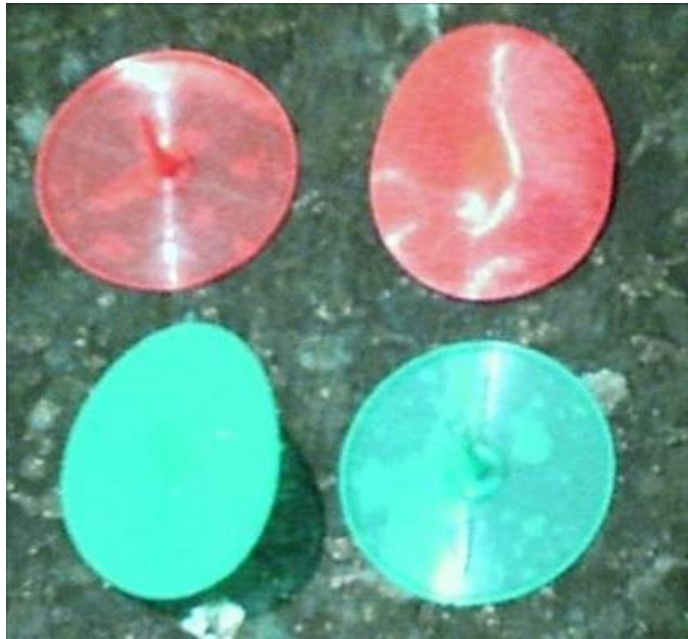
**Fig 4-13:** Flat flapper valves produced using the injection mould tooling, showing the colour coding matching the hose caps. The top left valve and bottom right valve has sealed to the smooth granite surface under its own weight.

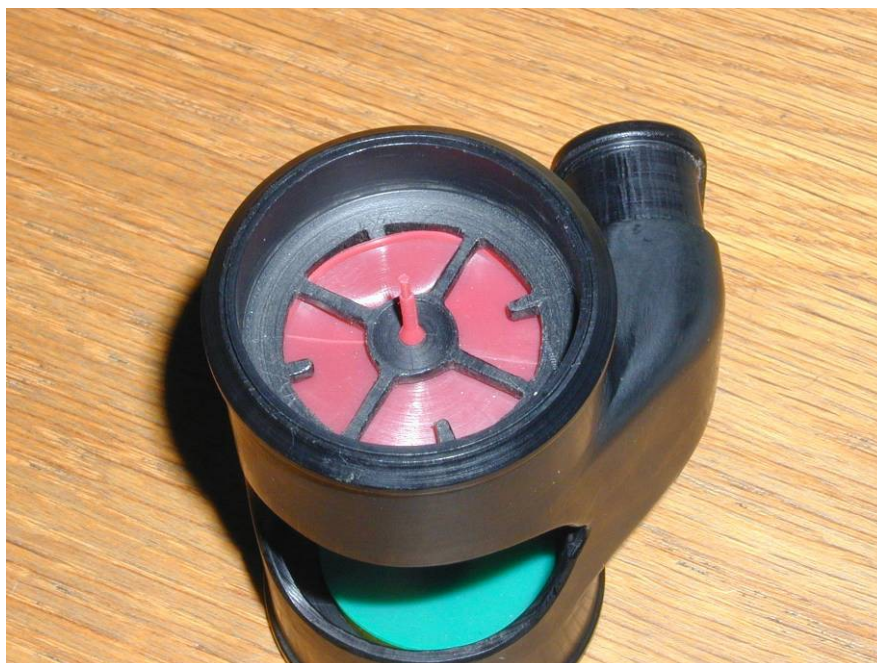
**Fig 4-15:** Example of flapper valve failure with half finger alternatives (rejected). A plain DSV was used for these tests.

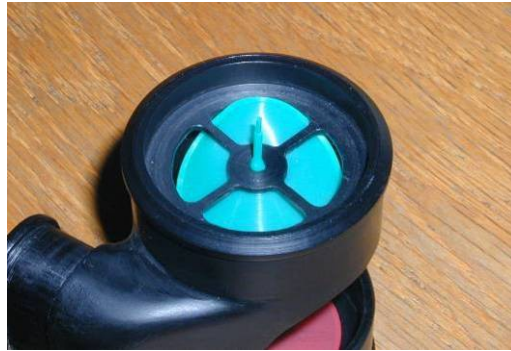
**Fig 4-16:** Example of flapper failure with four finger alternative. The valve does correct itself immediately when breathed, but as four fingers can leak, five fingers was regarded as the borderline case and the design was set to the web with six fingers. The face of the web seen here is being moulded, with projections to prevent the flapper being inserted on the top surface, and the web colour matching the flapper component.

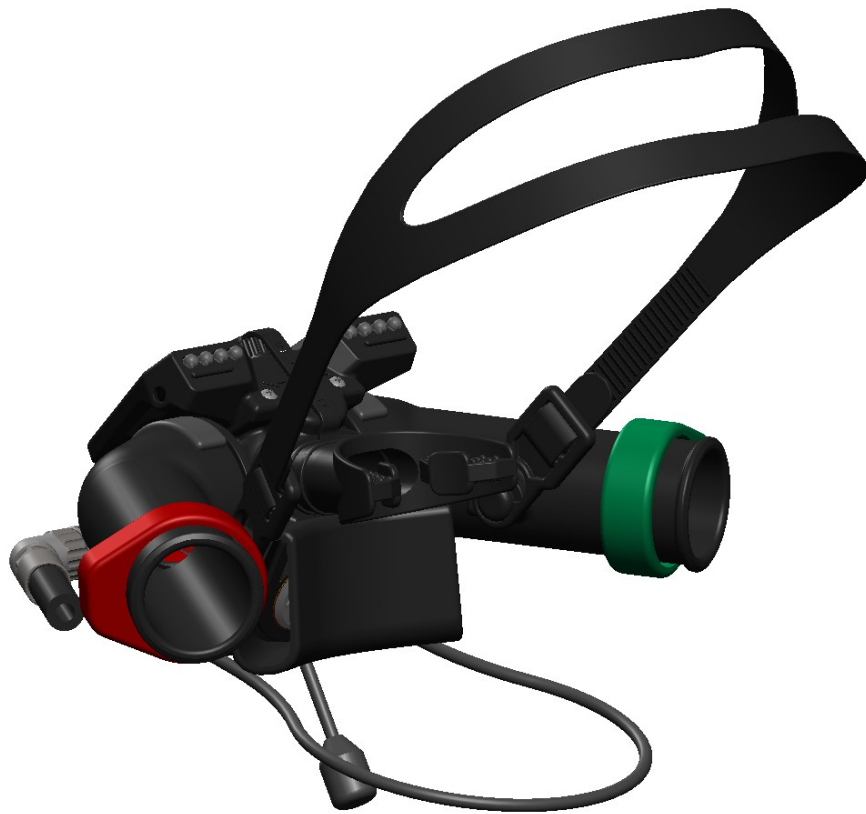
**Fig 4-23:** General view of ALVBOV with PFD. View from the rear

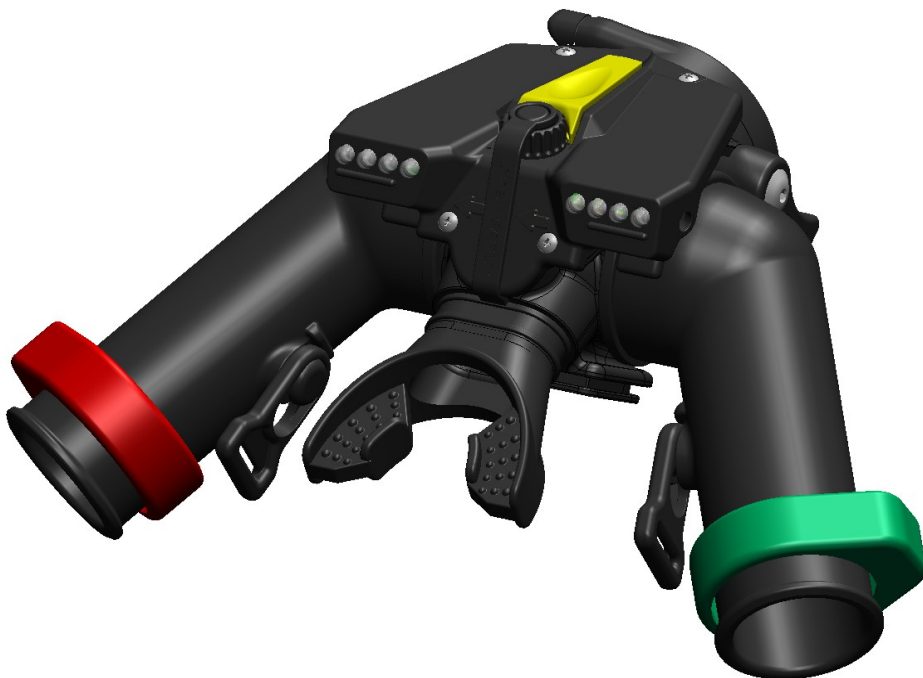
**Fig 4-24:** General view of ALVBOV with PFD. View from the rear, upper, with straps removed

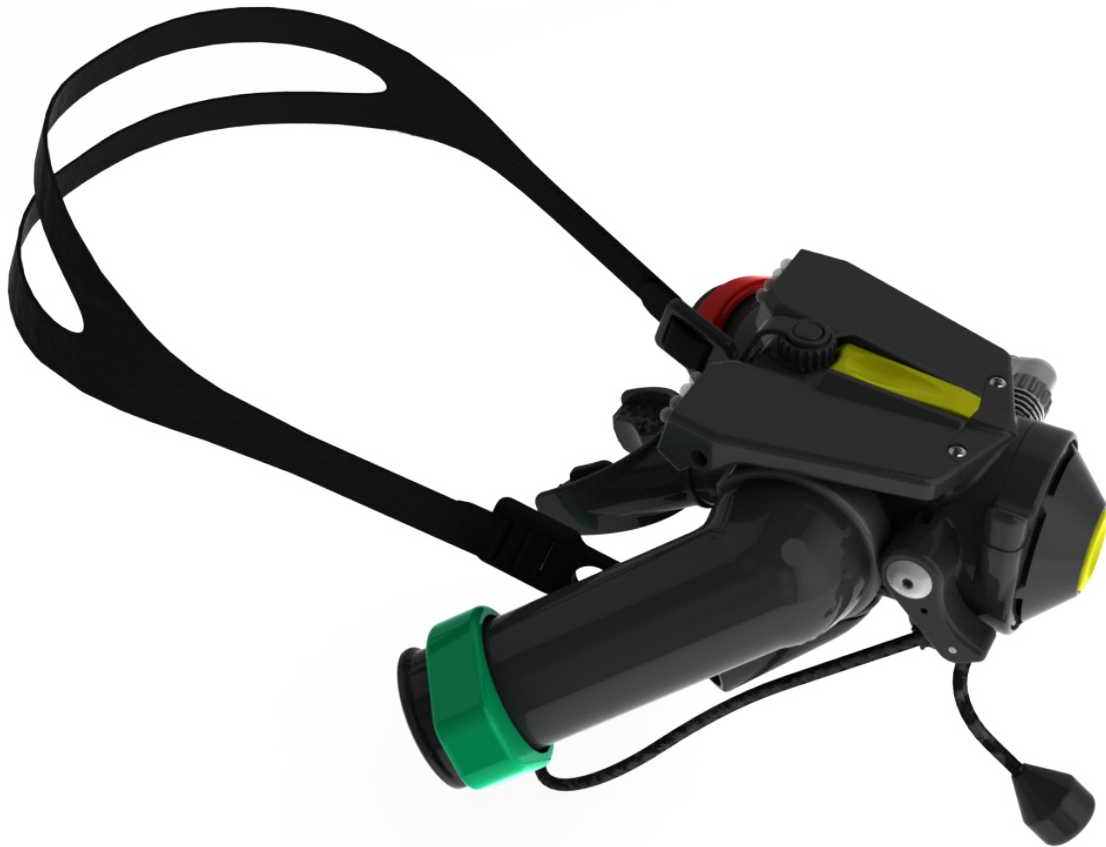
**Fig 4-25:** General view of ALVBOV, side showing the head strap and pull cord.

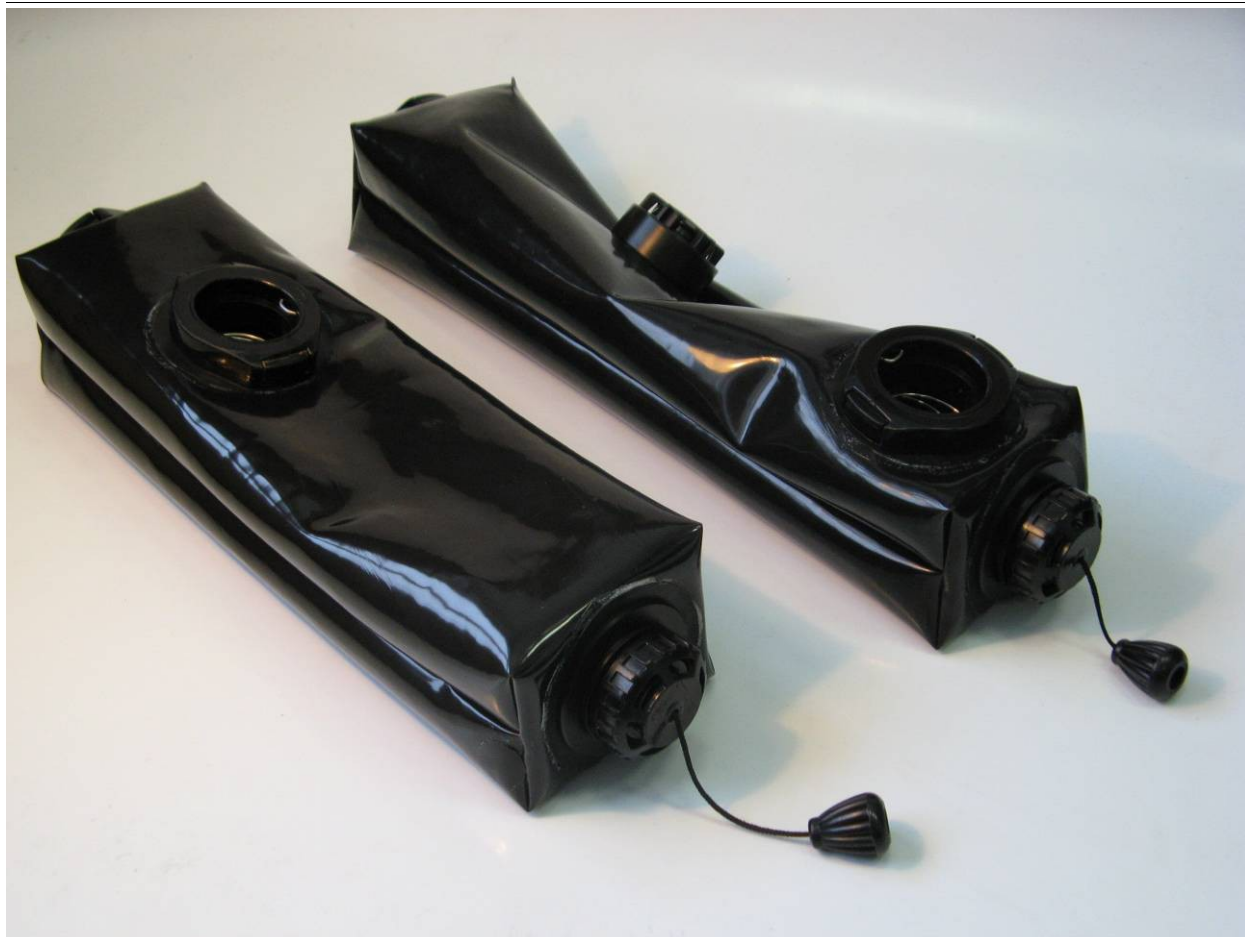
**Fig 4-30:** Examples counterlung construction, showing water dumps, gas access spring, reinforcement rings on ports and OPV (on the inhale counterlung shown on the right).

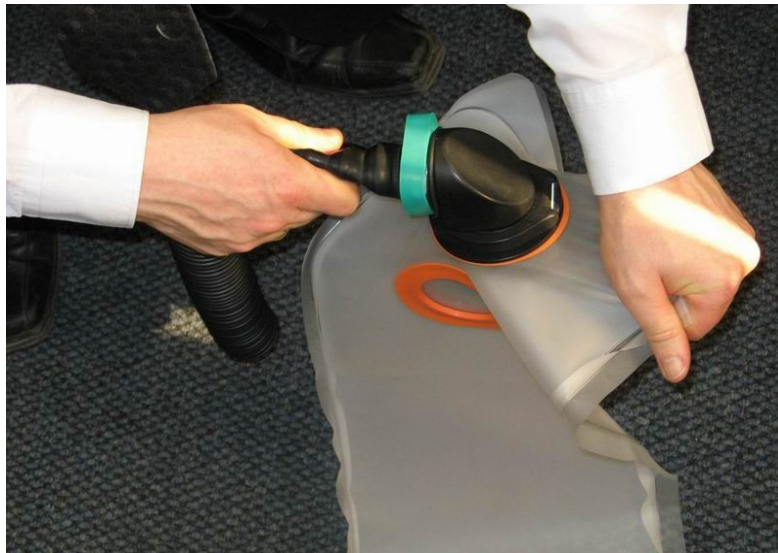
**Fig 4-32:** Test of counterlung port reinforcement and mating with maximum force to pull the hose from the bare counterlung using thinner counterlung TPU to increase the stretch: the production TPU is 600 micron thick and not easily stretched. Even under these conditions hose was retained. The example above uses the thinnest counterlung material. The above test was configured specifically using counterlung material that would manifest the failure if the failure mode existed. This test was repeated with a 50kg and 100kg weight, without any failure of the hose clamp, hose, port or port from the counterlung. Test indicates that the reinforcement ring is effective at achieving its designed function, namely to prevent the failure where the port pulls free of the counterlung.

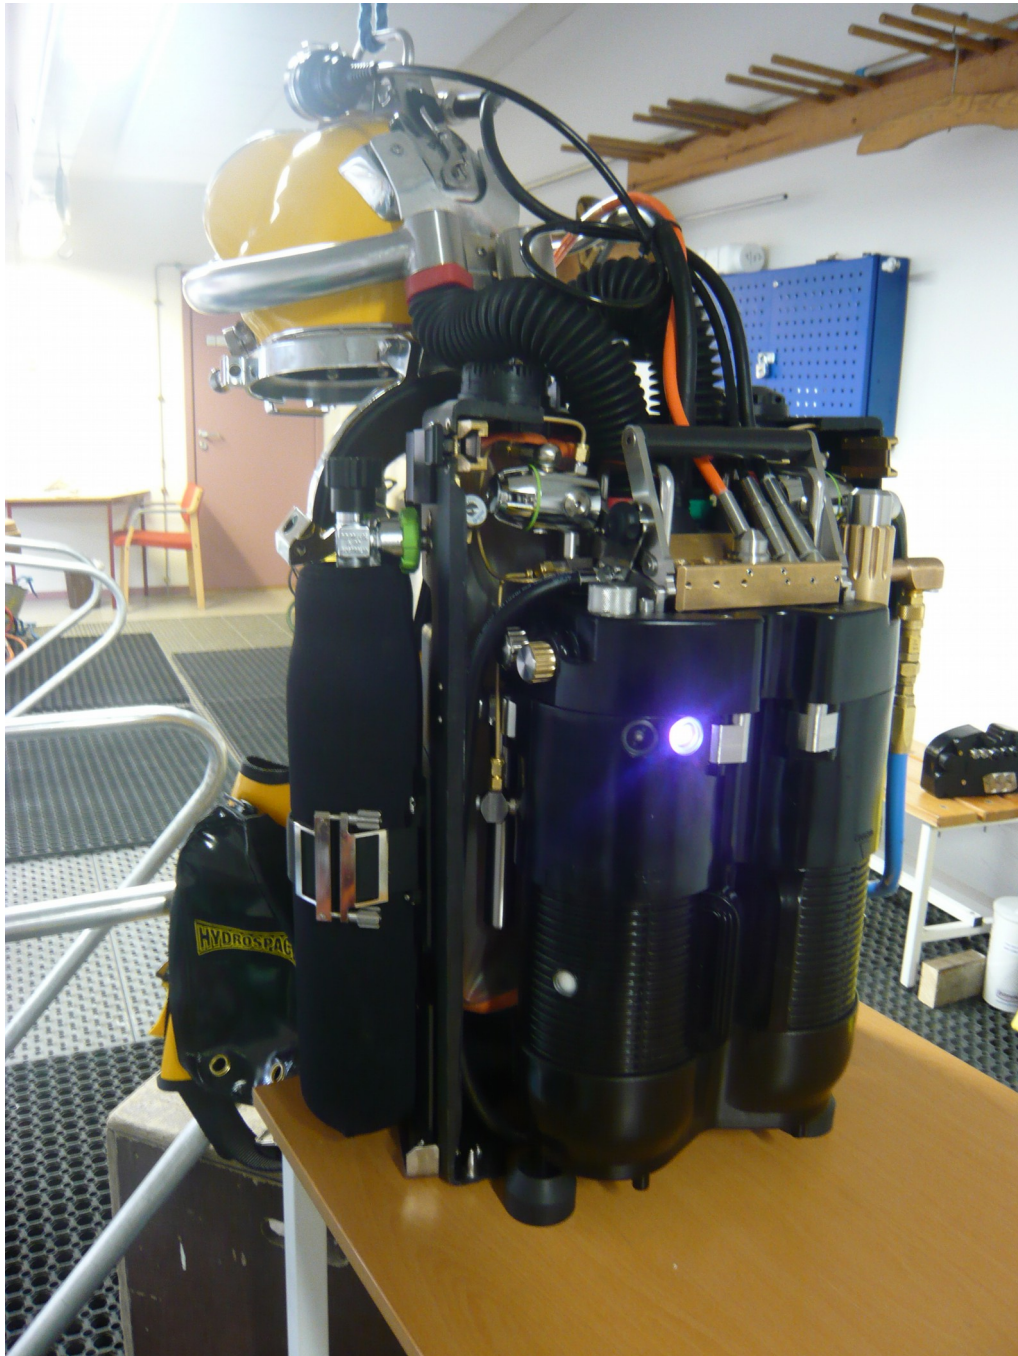
**Fig 4-33:** Commercial diving scrubber canister assembly showing viewing ports and buddy status lights.

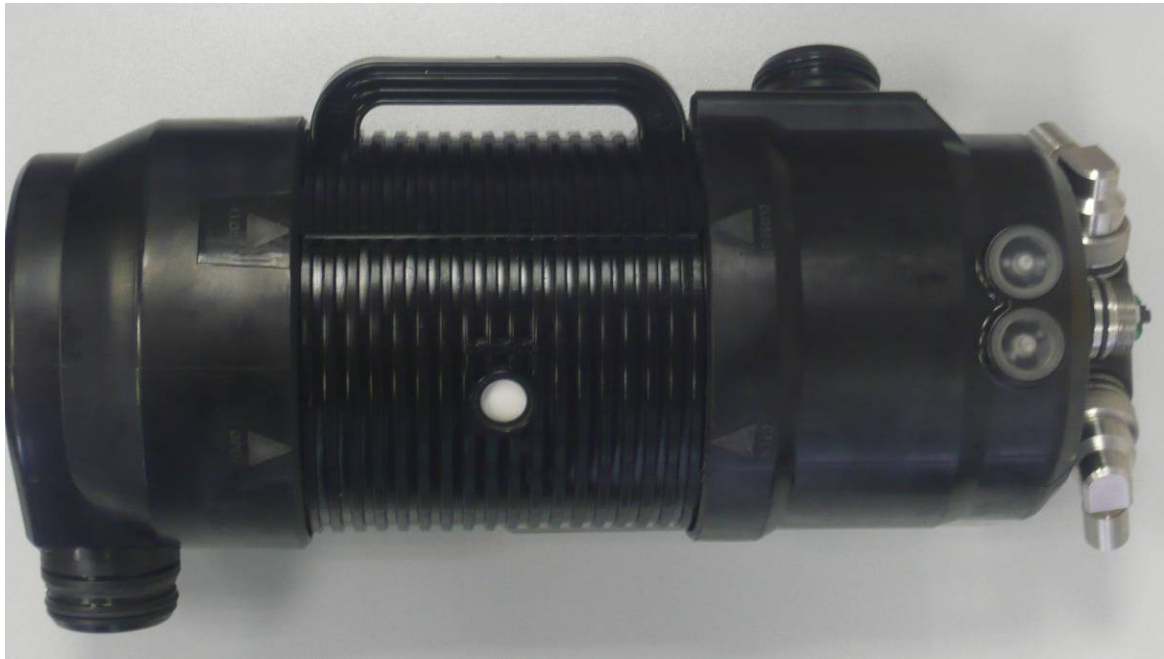
**Fig 4-34:** Multi-role professional eCCR configuration showing the scrubber viewing port: the same scrubber barrel is used on all units, and all contain the scrubber viewing port.

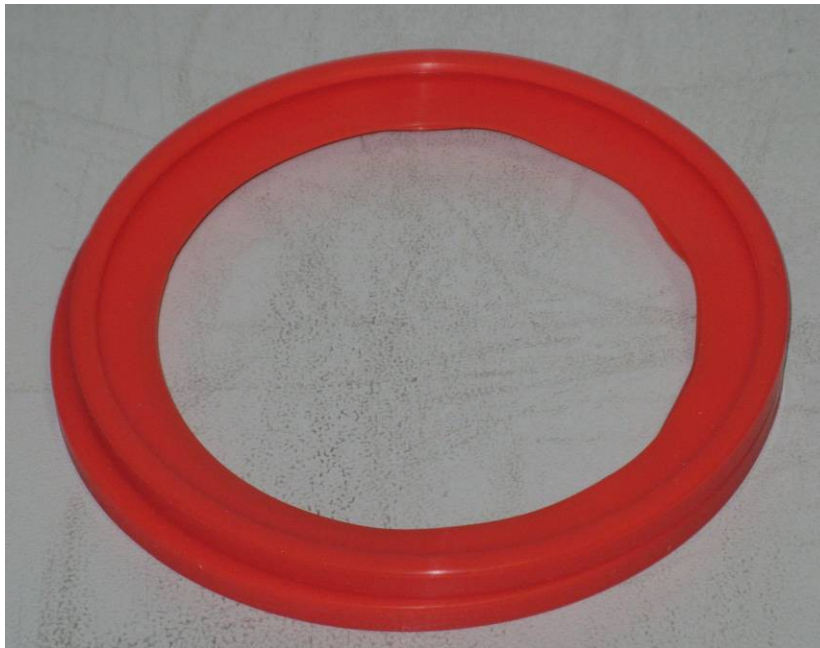
**Fig 4-35:** EAC seal after three days of immersion in silicone oil, showing swelling but otherwise still functional. The seal is tolerant of all other common chemicals, and of strong bases (caustic compounds).

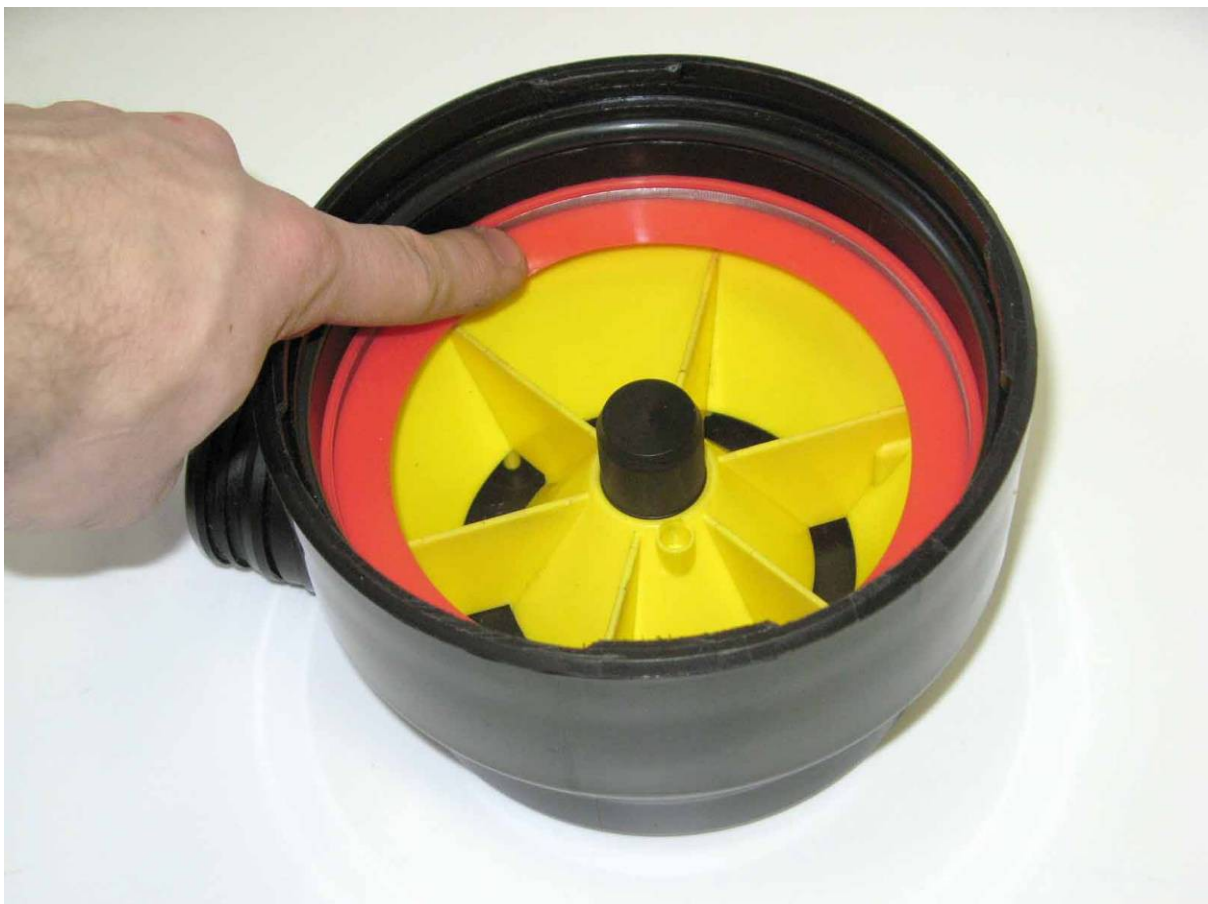
**Fig 4-36:** EAC seal moulded in red, contrasts well with both black and yellow flow cones, allowing the diver to inspect the seal easily each time and EAC is fitted.

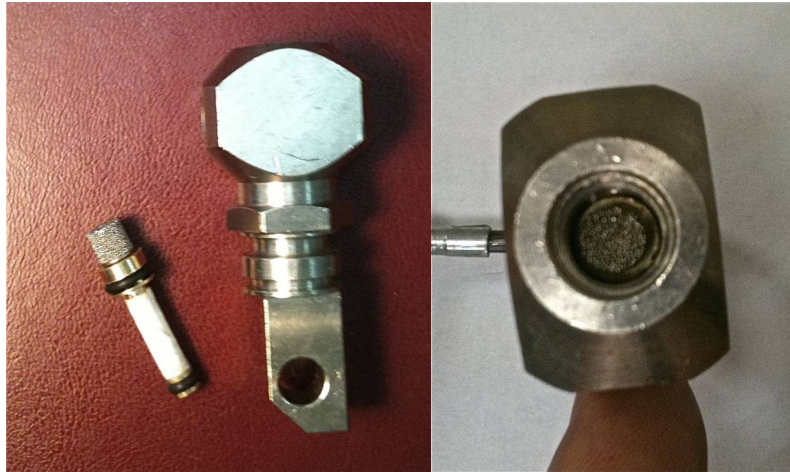
**Figure 4-1:** Inlet filter comprising a sintered filter and a hydrophobic membrane filter, fitted to the connector providing gas into the injector.

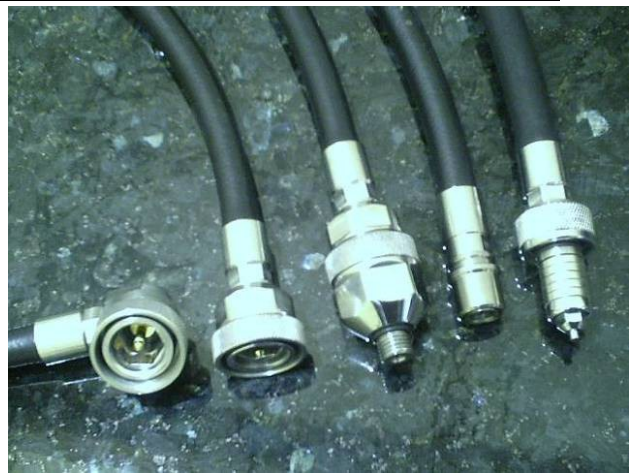
**Fig 4-41:** Realisation of each of the connectors shown in the CAD image to the left.
